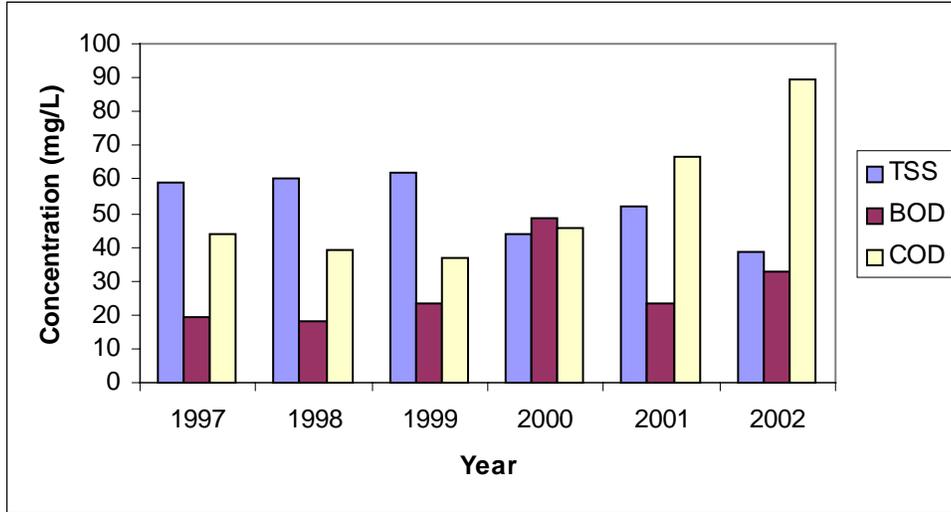
**FIGURE 3.2-10** Yearly Averages for Water Quality at the Calexico Gage on the New River at the U.S.-Mexico Border (Source: CRBRWQCB 2003a)

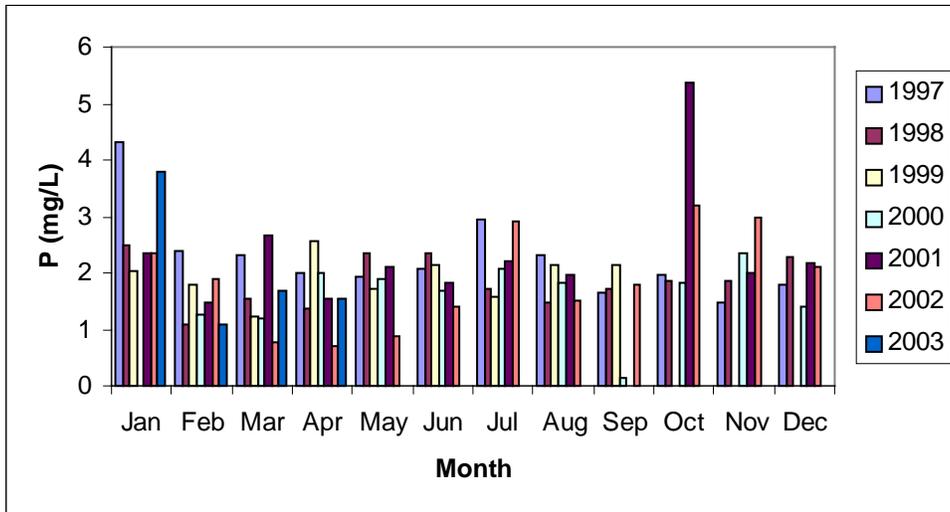
**FIGURE 3.2-11** Concentration of Total Phosphorus at the Calexico Gage on the New River at the U.S.-Mexico Border (Source: CRBRWQCB 2003a)
